ECHO ROUNDS Section Editor: Edmund Kenneth Kerut, M.D.

## A Bileaflet CarboMedics Aortic Valve Prosthesis with a New Unusual “Linear” Central Regurgitant Jet: A Sign of Subtle Incomplete Closure of One Leaflet?

(Echocardiography 2012;29:505-507)

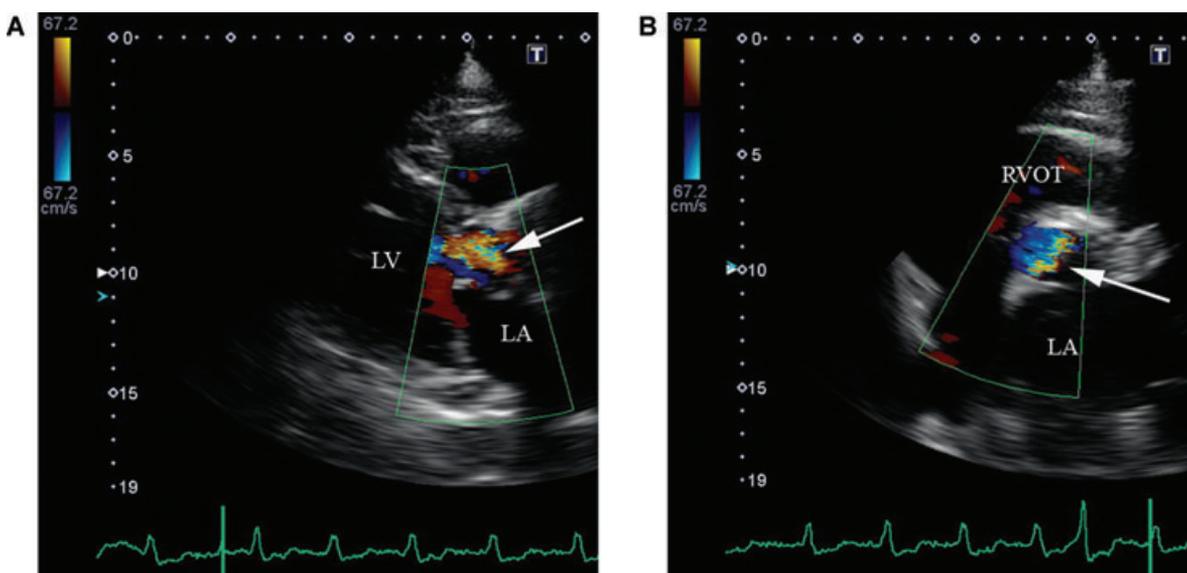
A 76-year-old retired physician underwent routine follow-up echocardiography for a 29-mm CarboMedics bileaflet mechanical prosthesis (Sorin Biomedica Cardio, Arvada, CO, USA) placed 8 years earlier, for aortic stenosis. A new “linear central” prosthetic aortic regurgitant jet, directed toward the left ventricular septum, was noted by transthoracic echocardiography (TTE) (Fig. 1, movie clips S1 and S2), compared to a TTE 3 years earlier.

**Figure 1.** Parasternal imaging in diastole. **A.** Long-axis image—a prosthetic valvular color jet directed toward the interventricular septum (arrow). (LA = left atrium; LV = left ventricle). **B.** Short-axis image—the diastolic jet appears to be “central valvular” and “linear” in shape (arrow). (RVOT = right ventricular outflow tract).

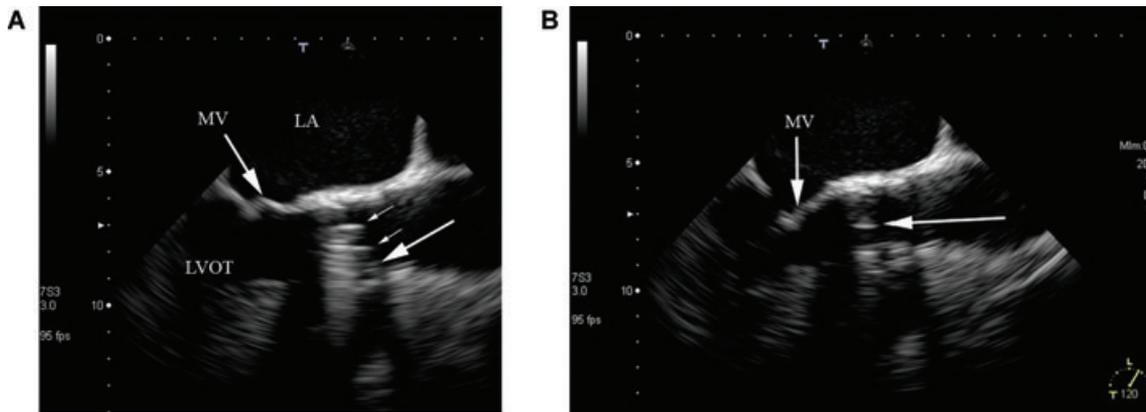
Because of the unusual color Doppler appearance of the regurgitant jet, both transesophageal echocardiography (TEE) (Fig. 2, movie clip S3) and fluoroscopy of the valve were performed (Fig. 3, movie clip S4). By TEE both leaflets appeared to open and close normally. Presumed

**Figure 2.** TEE in the esophagus at 120°. **A.** Systolic frame—the prosthetic valve leaflets appear to open fully in systole (small arrows). Although suspicious echoes were noted within the valve annulus (arrow), no definite diagnosis of pannus formation could be made from these images. (LVOT = left ventricular outflow tract; MV = mitral valve). **B.** Diastolic frame—the prosthetic valve leaflets appear to fully close (arrow).

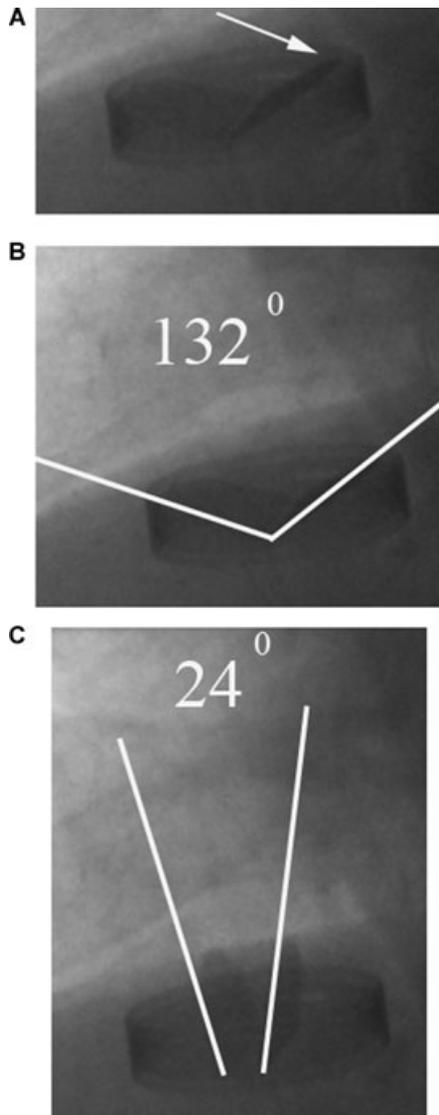
pannus formation within the valve annulus could not be definitely demonstrated. By fluoroscopic imaging, one of the leaflets appeared to not close completely within the annulus of the valve (Fig. 3A), despite the fact that the closing angle (132°) was within the normal reported range for that valve.

**Figure 3.** Fluoroscopy of bileaflet tilting disc CarboMedics prosthetic valve. **A.** Diastolic frame reveals that one leaflet does not completely close within the prosthetic valve annulus, but above it (arrow). **B.** Diastolic frame closing angle 132° and **C.** systolic opening angle 24° are within normal reported parameters.

particularly with measurement of opening and closing angles.<sup>6,7</sup> It appears that despite “normal” measured opening and closing angles, one leaflet did not completely close within the annulus.

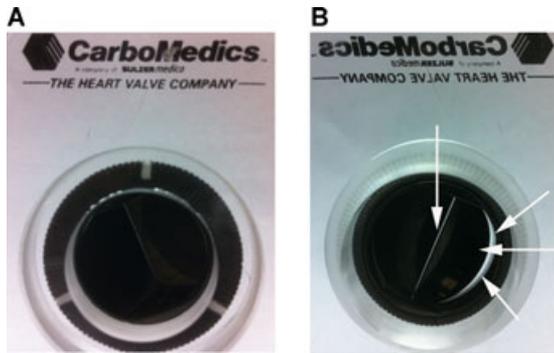
To further evaluate the linear color jet, a model of a CarboMedics bileaflet valve was evaluated. When both leaflets were completely closed, there was no “space” noted in the central line of closure (Fig. 4A). However, if one leaflet did not completely close, a valvular “central space” was noted (Fig. 4B). This demonstrated space due to incomplete leaflet closure appears to explain the new linear central diastolic color jet observed with this patient. Presumably, no regurgitation in the patient was noted in the paravalvular area secondary to annulus pannus ingrowth abutting the leaflet.

**Figure 4.** Model of CarboMedics bileaflet aortic valve prosthesis. Photograph looking “up” toward the valve, as if viewing from within the left ventricle. **A.** Both leaflets are fully closed. No “space” is found in the central line of closure. **B.** When one leaflet did not completely close (horizontal arrow), a “central space” at the leaflet line of closure (vertical arrow) was noted (Fig. 4B). This space appears to explain the new linear central diastolic color jet. Presumably, a perivalvular leak was not evident, as pannus would “fill” this potential space (diagonal arrows).
